# Naval Surface Warfare Center Carderock Division

CARDIVNSWC-61-TR-1999/13

## Investigation of a Roof Tube Failure From a Utility Boiler

David A. Shifler

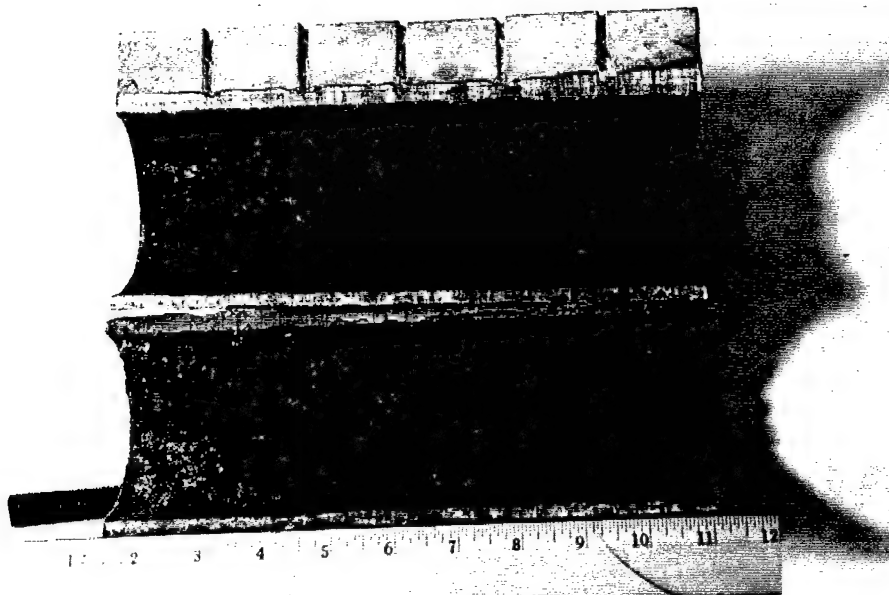
Figure 1 shows that the tube failure consisted of a one-inch longitudinal split along the hot side. This split coincided with local bulging of the tube at the hot side crown. The tube sample was cut along the longitudinal, membrane axis. Figure 2 shows that heavy deposits exist around the failure along the hot portion of the tube. A moderate amount of waterside deposition had occurred along the tube membranes; deposits were lowest along the cold portion (back side away from the flame). A side view of the respective waterside deposits (Figure 3) indicated that the hot deposit was one-inch thick in some places along the sample. The cold side deposit was approximately 0.020 inch thick near the tube membrane, while the deposit along the center of the cold side were less than 0.005 inch thick.

Figure 2 - Waterside surfaces of roof tube display heavy deposits on hot side (bottom tube half). Moderate deposits located at the tube membranes with lesser amount on the cold side.

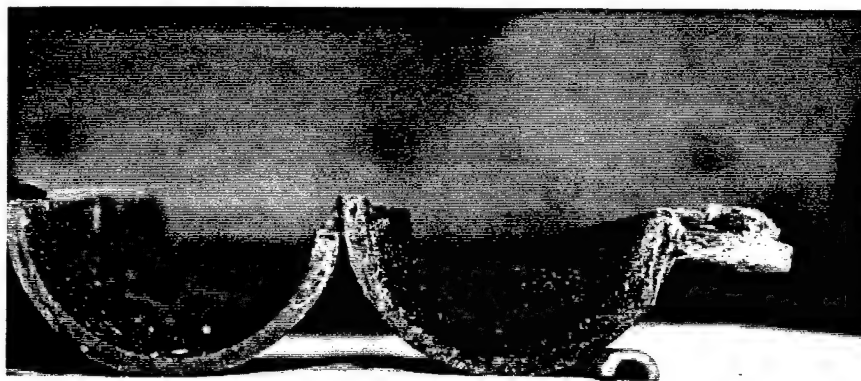
Figure 3 – Side view of tube sample reveals that hot side deposits are as much as 1.0 inch thick. Relatively little deposition was present on the cold side.

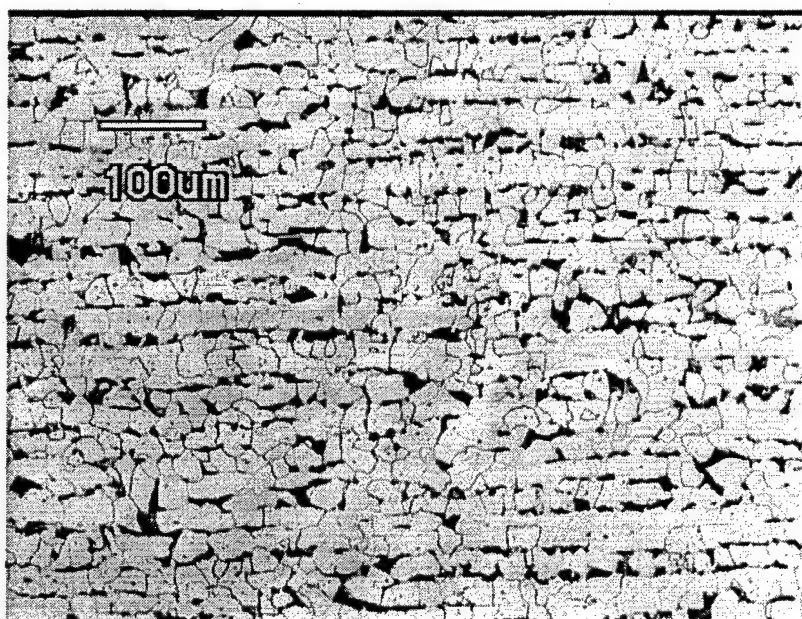
Specimens from the hot side and cold portions of the tube were selected for metallographic evaluation. The microstructure along the cold side (Figure 4) displayed a slightly banded configuration of ferrite and pearlite – a normal morphology of low carbon steel.

Figure 4 – Microstructure of the cold side displays a slightly banded ferrite morphology with pearlite. Magnification - 210X.

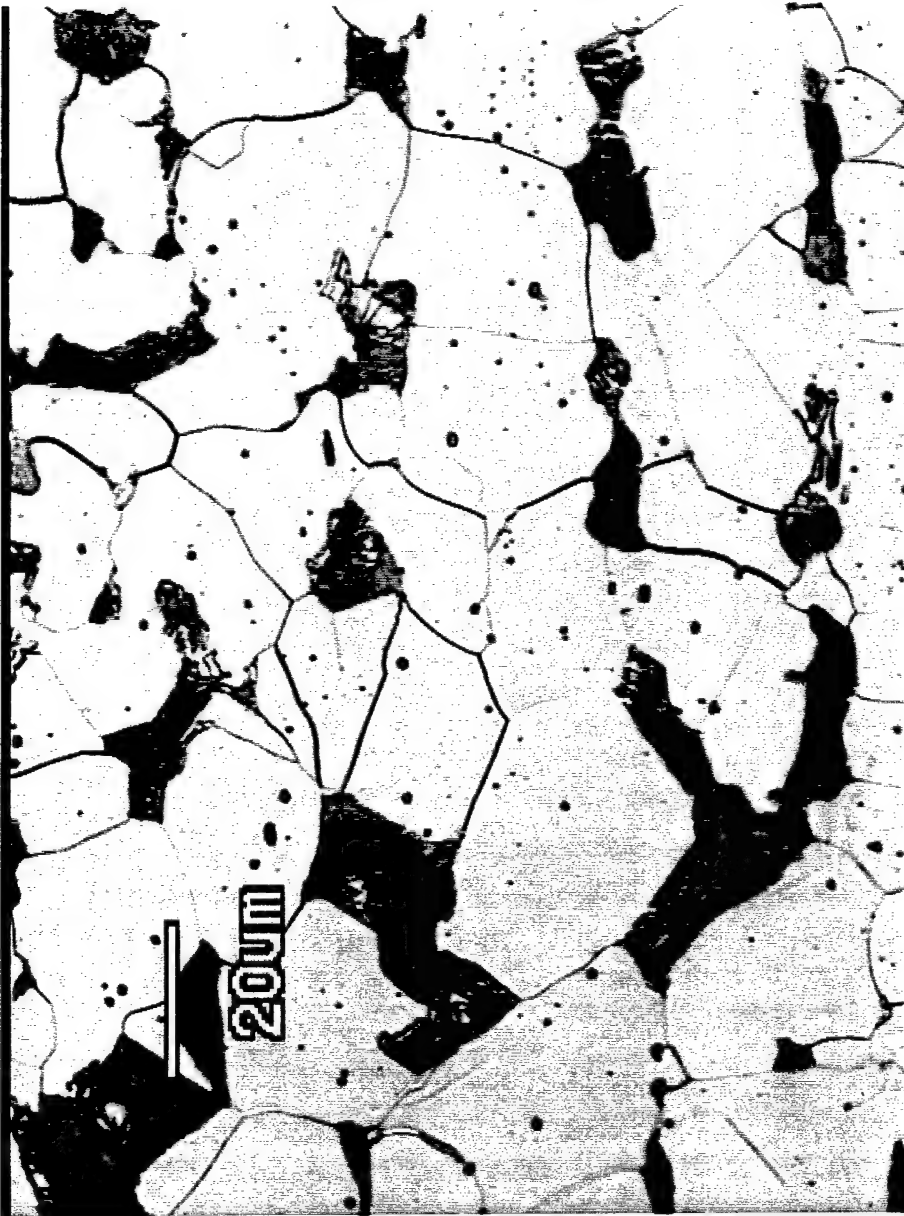
A magnified view of the cold side microstructure (180° and opposite from the failure) as shown in Figure 5 attests to the lamellar nature of the pearlite colonies in the ferrite matrix. Dark intragranular phases are observed and are likely composed of minor alloy constituents such as iron and manganese sulfides or silicates as well. The 0.004-0.006 inch thick waterside deposit, shown in Figure 6, along the cold side tended to porous. Some copper metal was located in the deposit.

Figure 5 – Magnified view of Figure 4 microstructure shows the lamellar carbides in the pearlite colonies. Spherical phases are small alloy constituents such as oxide and sulfide inclusions. Magnification - 1050X.

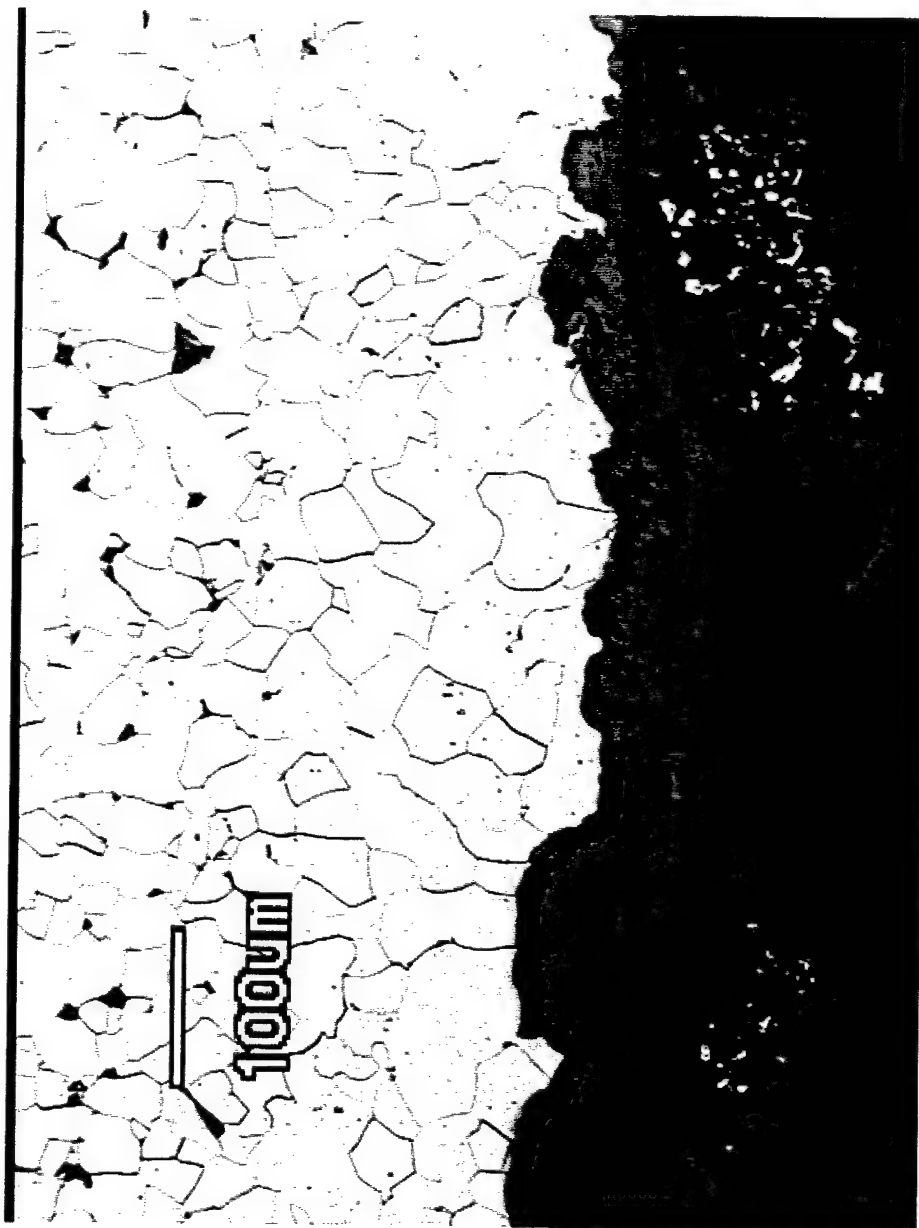
Figure 6 – Cold side oxide scale is about 0.004-0.006 inch thick, but tends to be porous. Copper metal is mixed in the deposit. Magnification - 210X.

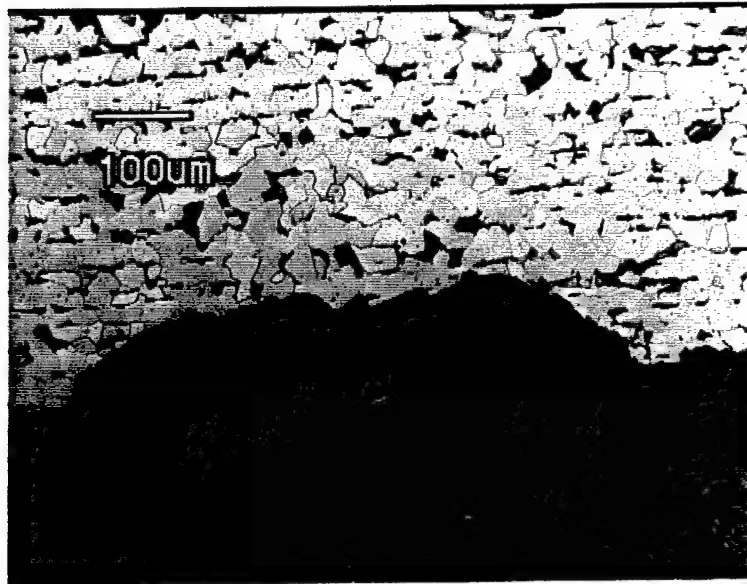
The microstructure along the hot side crown of the tube, but about 4 inches from the failure (Figure 7), discloses a relatively dense waterside deposit 0.001-0.002 inch thick with a more porous layer 0.003-0.011 inch thick. Copper metal particles are interspersed in the more porous layer. The tube substrate displays a matrix of pearlite and ferrite that shows no signs of thermal degradation as confirmed by the magnified photomicrograph in Figure 8.

Figure 7 – Microstructure along hot side crown displays a thick waterside deposit with some mixing of copper metal particles. The underlying tube matrix has not been overheated. Magnification - 210X.

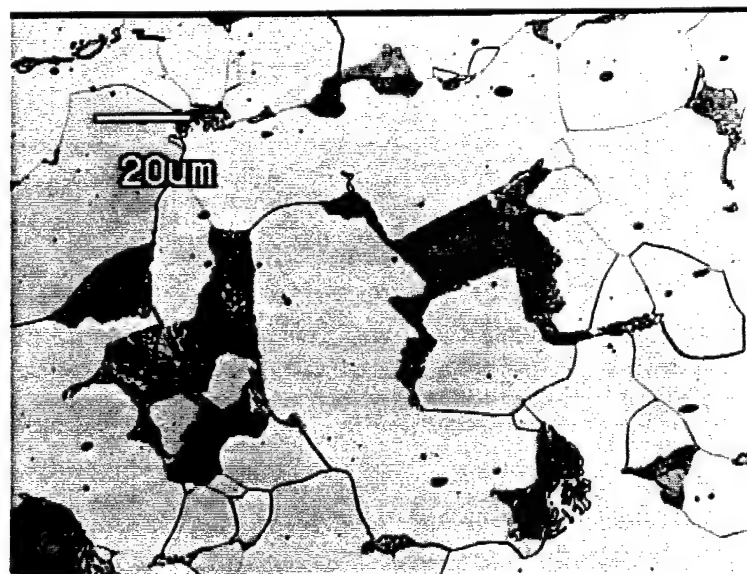
Figure 8 – Magnified view of Figure 7 shows no thermal degradation of the ferrite-pearlite tube matrix along the hot side area. Magnification - 1050X.

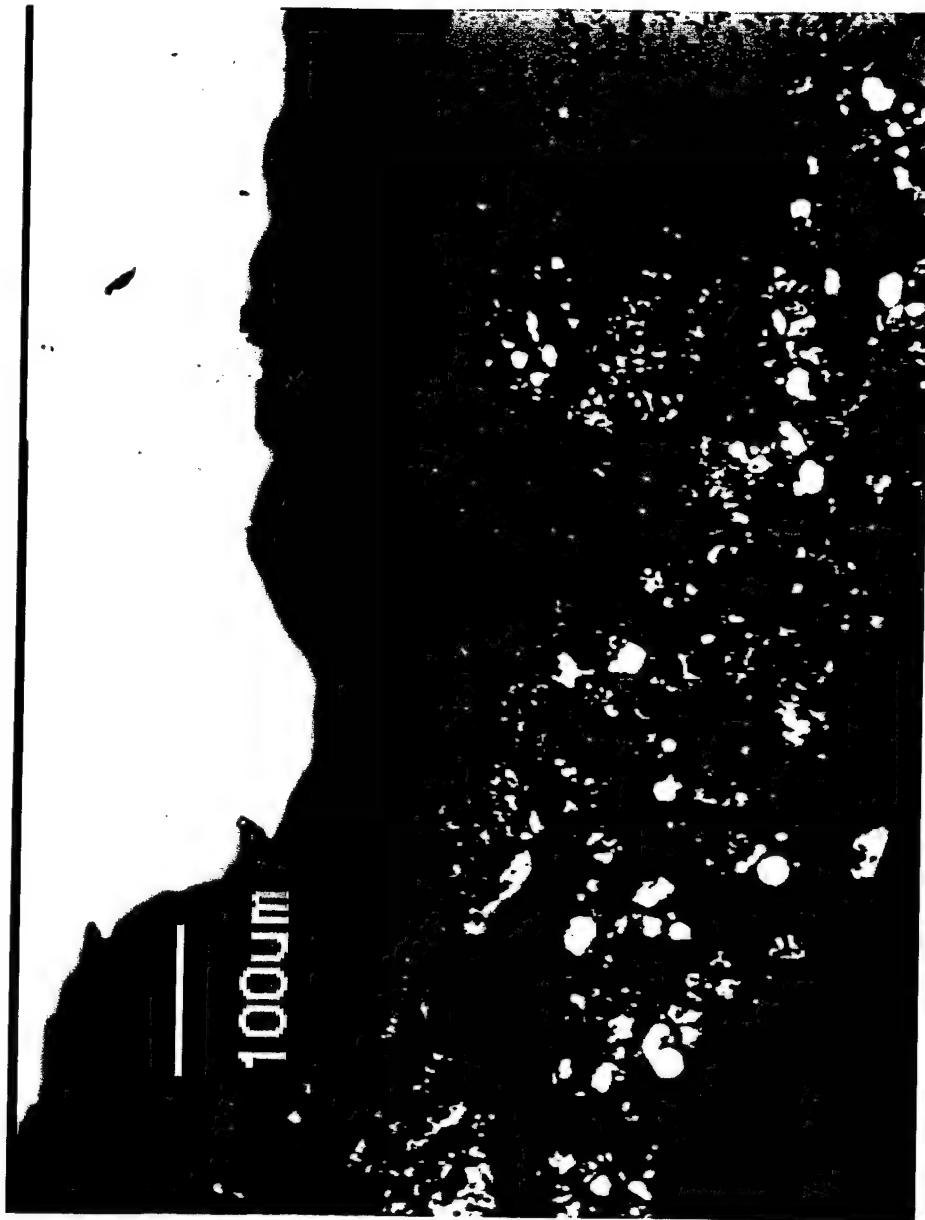
Figure 10 – Waterside deposit along hot side crown shows deposits containing mainly iron oxides, copper oxides, and copper metal. The high porosity of the thick deposit could provide opportunities for overheating. Magnification - 210X.

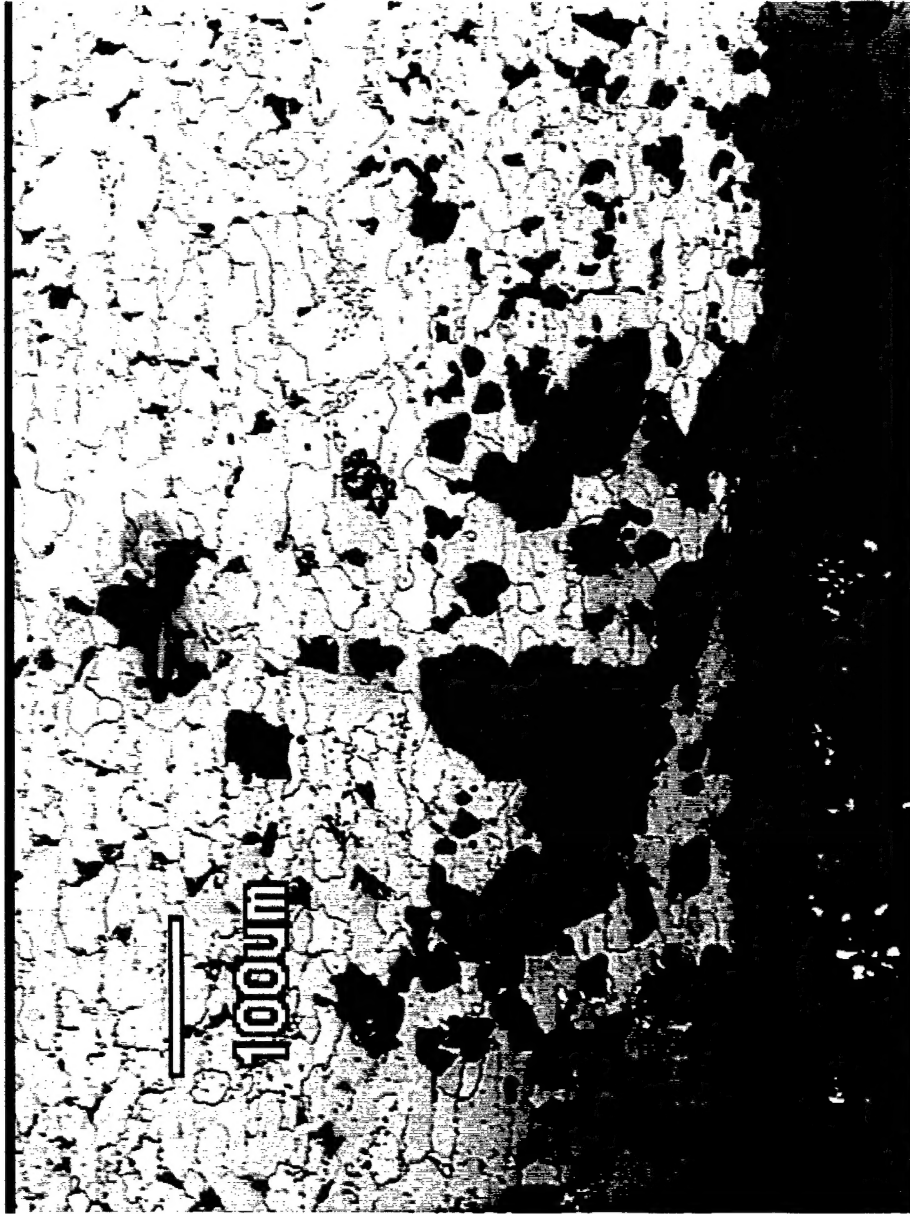
In Figure 11, the tube microstructure near the failure (~ 0.5 inch away) displayed complete spheroidization of the carbides from overheating. Voids developed at grain boundaries, particularly at three-grain junctions; these voids tend to be oriented perpendicular to the tube surface. The formation of these voids is due to long-term overheating and creep rupture. Some of the voids have grown and coalesced into larger voids and incipient microcracks; some of the largest voids have formed surface oxides. There is slight elongation of the grains as a result of tube swelling and expansion. The photomicrograph (Figure 12) shows a magnified view that clearly shows that the carbides at former pearlite colonies have fully spheroidized. Some of these carbides have dispersed into the grains. Other random carbides are present along the grain boundaries; , voids have formed at some of these grain

boundary sites. Void formation and propagation occurred in a direction perpendicular to the hoop stress.

Figure 11 – Waterside surface, hot side, near failure. Carbides in prior pearlite colonies have completely spheroidized from overheating. Creep voids have developed at grain boundaries; some of these voids have grown and coalesced. Magnification - 210X.

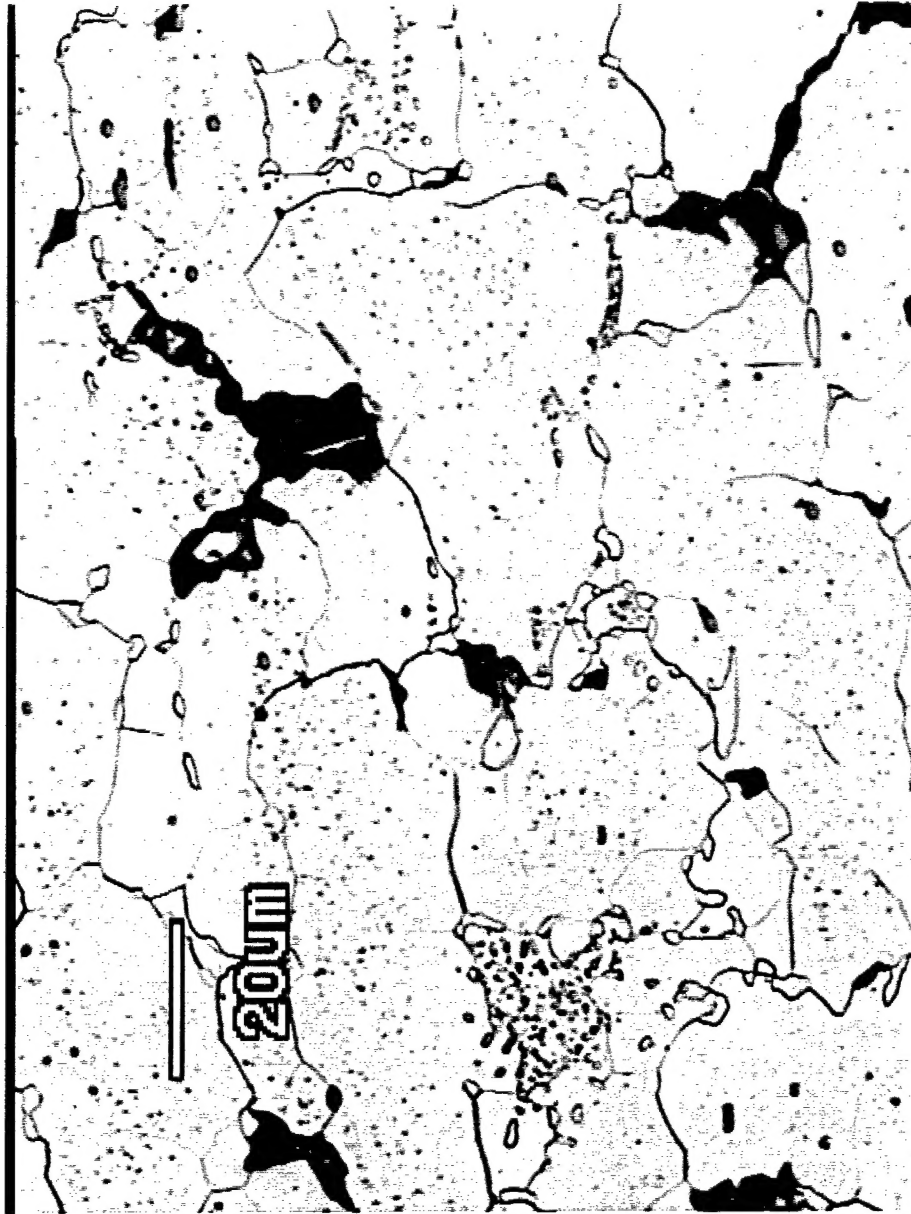
Figure 12 – Carbides are fully spheroidized from thermal degradation near failure. Voids (dark sites) have formed along the grain boundaries that are perpendicular to the direction of applied stress. Magnification - 1050X.

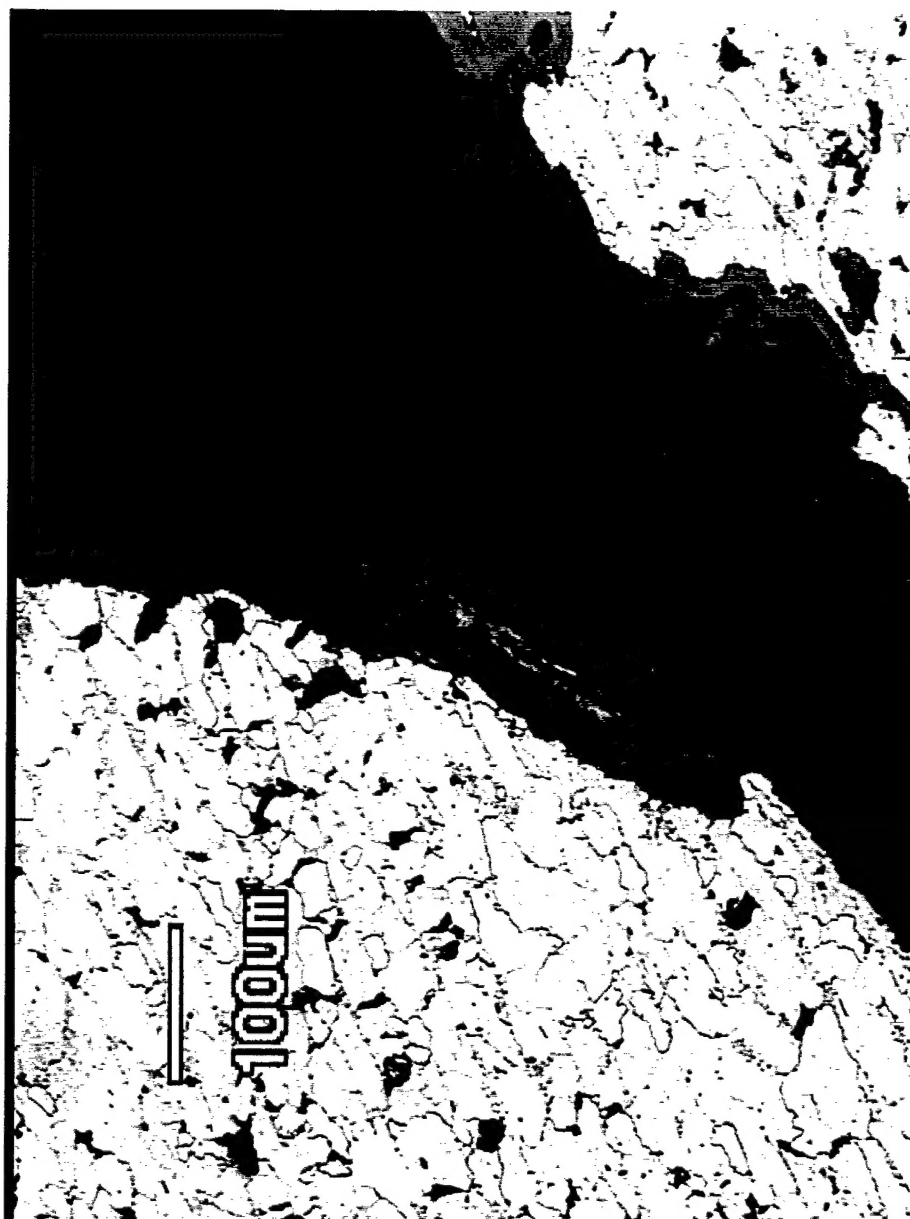
Voids initially formed at three-point grain boundaries, grew, and coalesced to form larger voids and microcracks. A few of these microcracks grew in the areas of highest stress to form macrocracks. Formation of these macrocracks increased the local applied stress, causing the cracks to grow with time. Figure 13 shows the macrocrack that led to a through-wall failure. The fracture surface is covered with a heavy oxide scale which appears to indicate that crack propagation occurred over a relatively long time. Some copper from the waterside surface has become embedded in the oxide scale.

Figure 13 - Fracture surfaces near tube midwall. The fracture surfaces are covered with a heavy oxide scale. Copper metal has been transported to this site. Creep voids found in the tube matrix along the fracture. Magnification - 210X.

Susceptible sections of the boiler where high heat transfer occurs should be evaluated for the presence of heavy deposits that could cause tube metal temperature to elevate to values that creep may be experienced during the normal life of the boiler. Tube sections with tube blistering or bulges should be further examined, and removed if necessary. If heavy deposits are found in sufficient areas and frequency within the boiler, chemical cleaning should be considered. The water treatment program should also be evaluated.
